No. 019

BLF Large Diameter SP taps for torn thread problems Cutting Taps

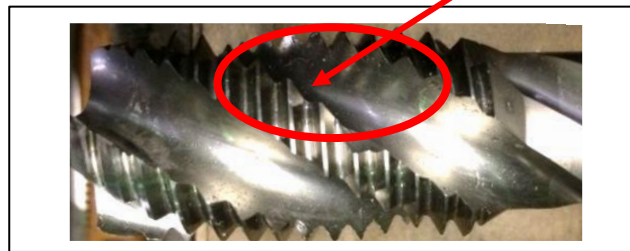
【Example】 Torn threads occurred after tapping 10 holes with a standard SP with no surface treatment.

Torn threads occur from a chipped flute in the full thread portion of the tap after the cutting chamfer.

- Seize: SP M36 x 4
- Workpiece material: SS400
- Machine: : Radial Arm Drilling Machine
- Tapping Oil: : Neat Oil

Torn threads when using large size taps are reduced by utilizing a Yamawa tap with a "BLF" special crest design.

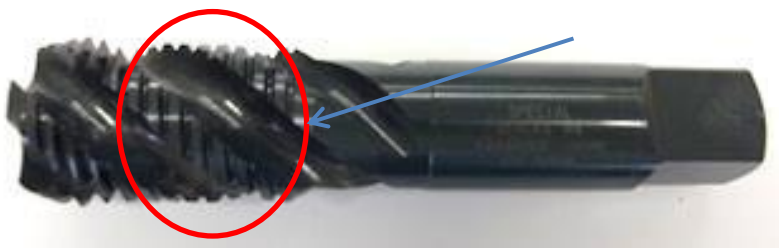
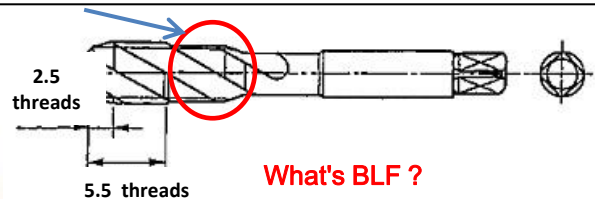
【BLF Ground Tap】

Yamawa uses an BLF improved heel cut on the full thread portion.

The unique tap is specially designed to have the first 3 threads at full height and the balance of the threads at about the Pitch Diameter in height.

No torn threads after tapped 250 holes

Good internal threads surface

These large diameter taps are more effective with an oxidation treatment as this helps the oil to stay on the flutes while cutting.

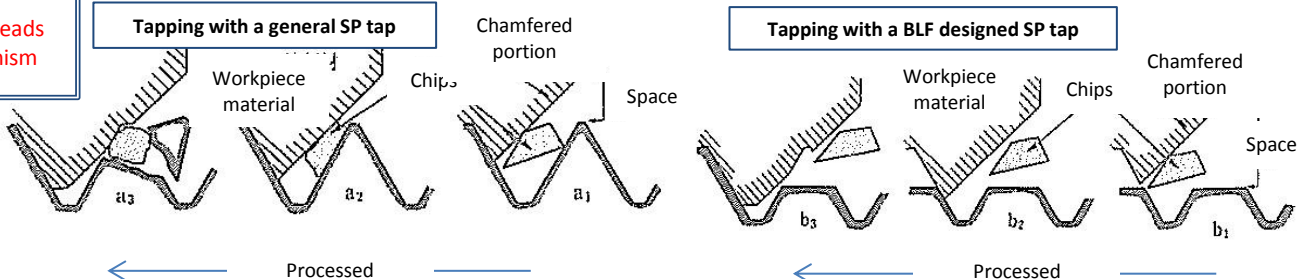
Torn threads mechanism

Improvements in chip ejection occur from the unique flute design and the advanced cutting edge angle. The BLF improved heel cut on the tap produces excellent cutting performances and results in the prevention of flute chipping problems. There is a marked improvement in tool life due to low thread height in the BLF area causing a decrease in friction resistance and preventing welding problems.
